Replacing the air filter on a CTX1300 (Mar 2018)

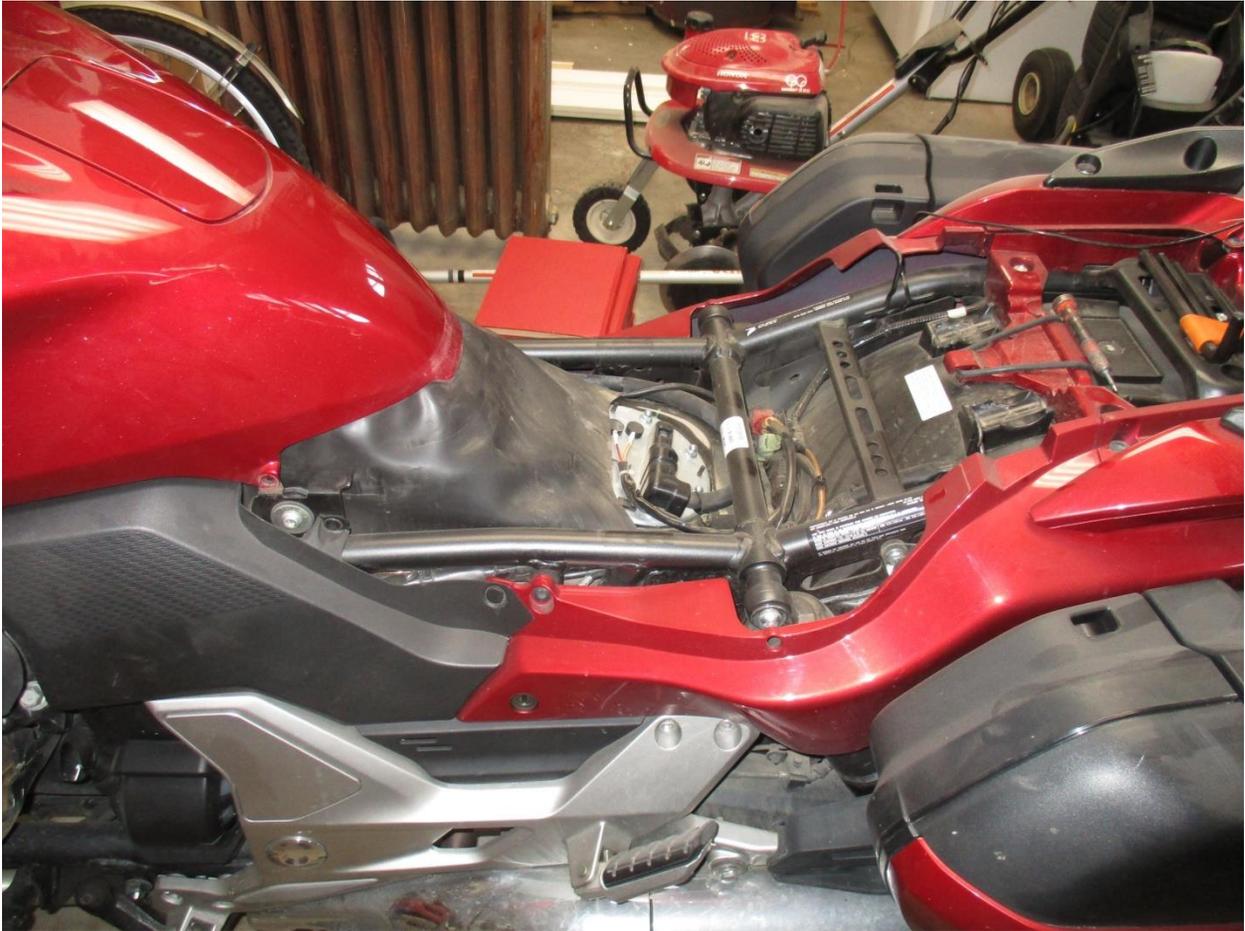
Remove the seat

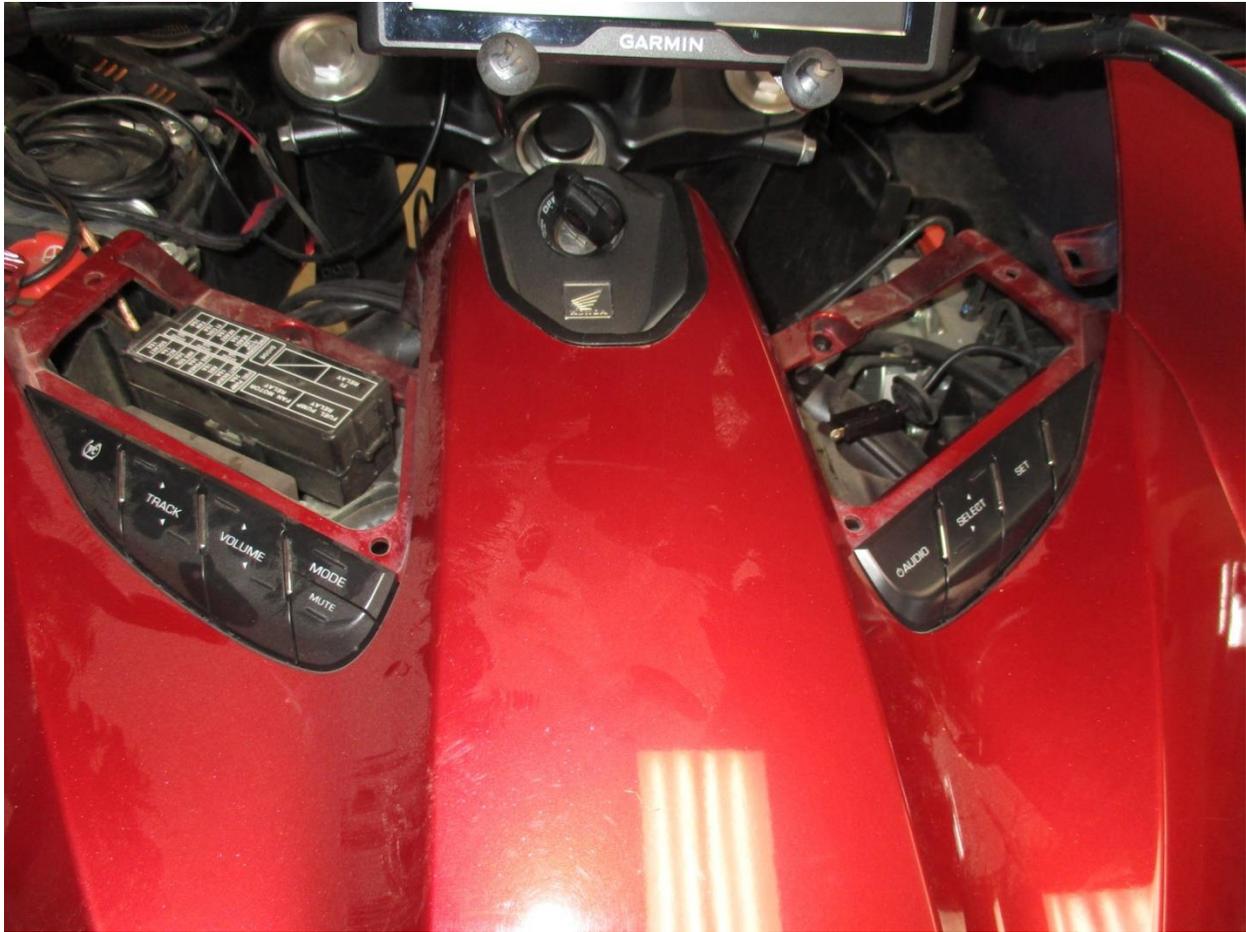
Remove the left & right pockets  
the right pocket has a USB cable through a grommet.  
The grommet can slip out of the pocket

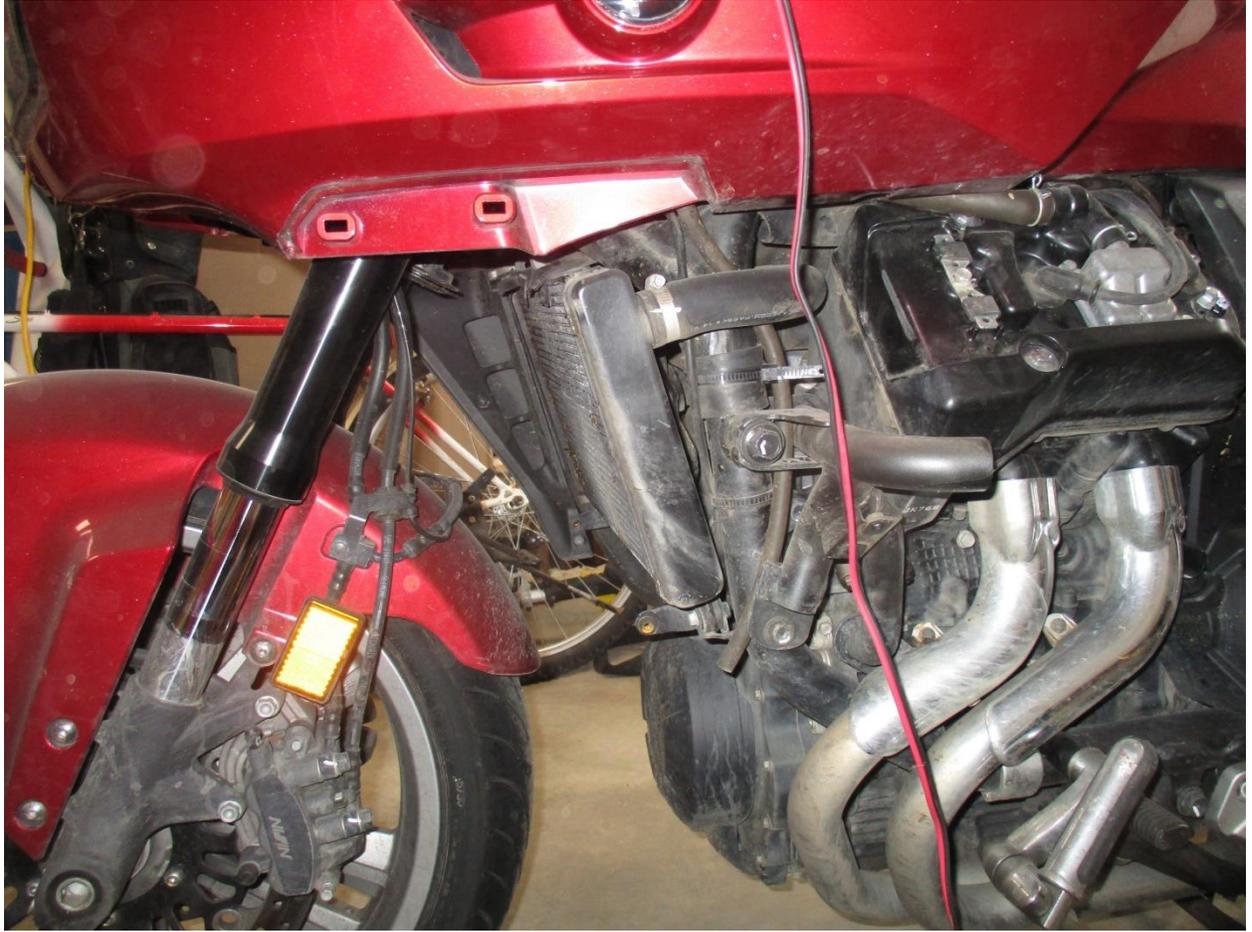
Next remove the lower cowling

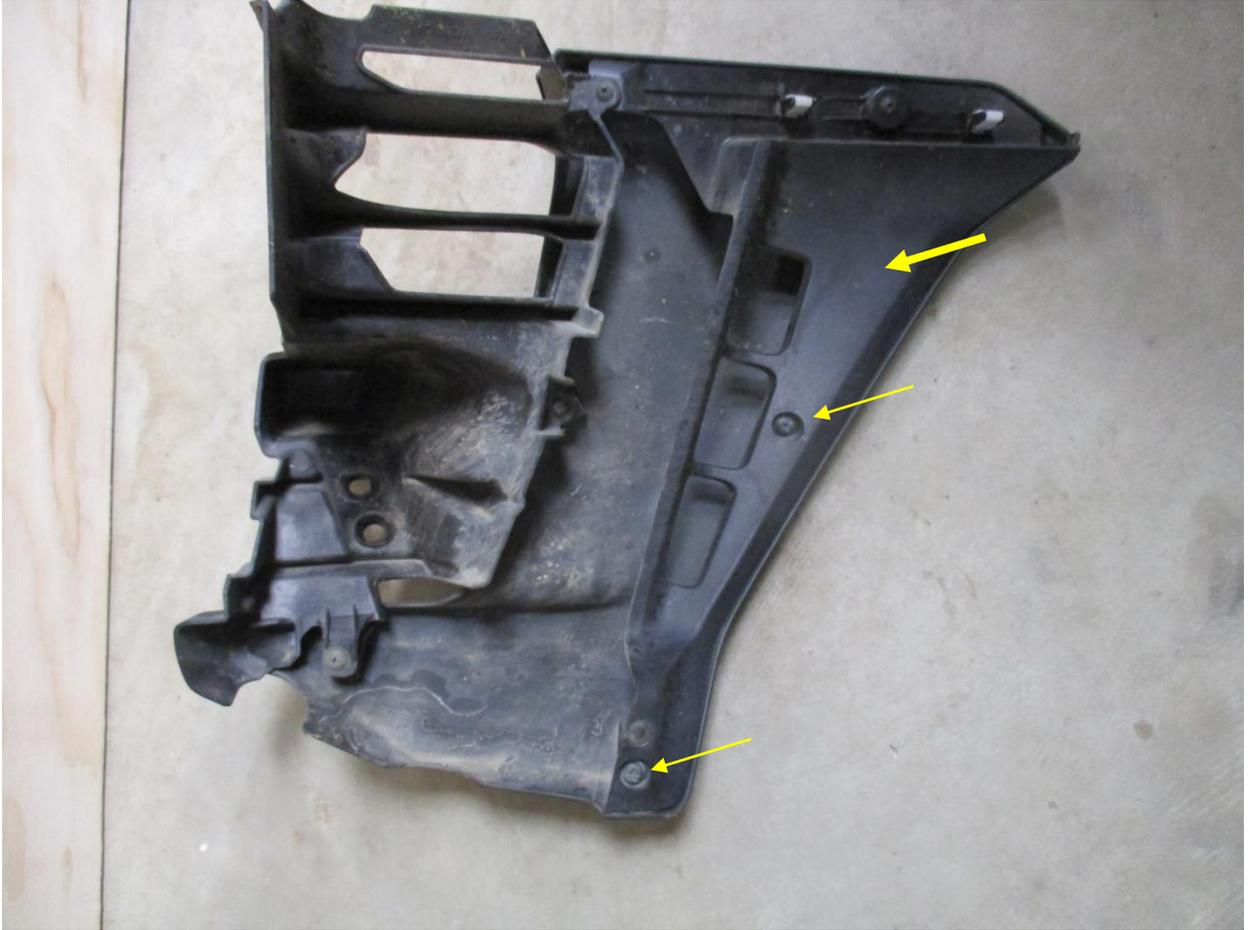
No need to remove these screws/ section

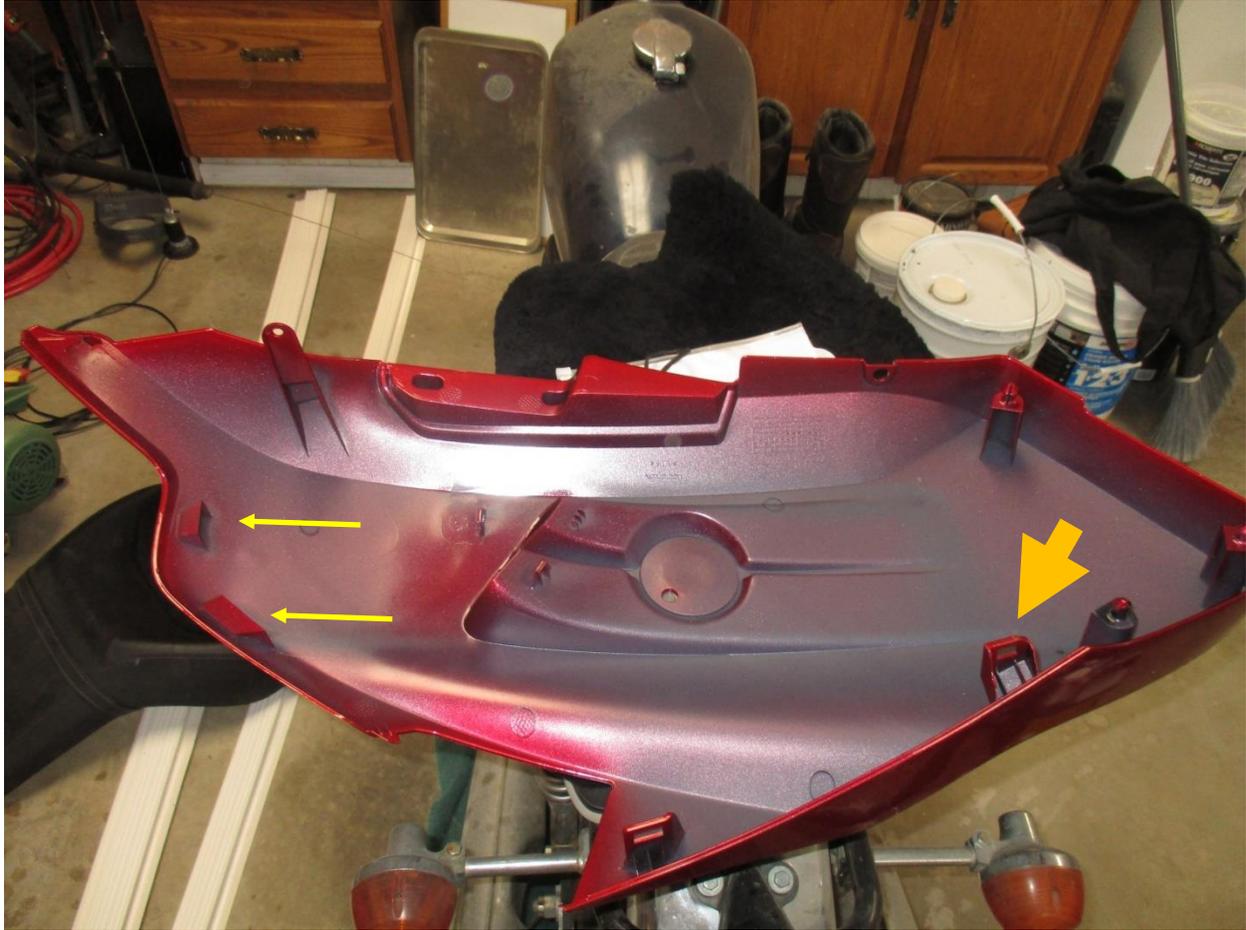
This is the left side of the upper cowling

I broke the identified tabs the first time I took it apart, so I bought a new one right away.

The 2 yellow clips I broke the first time.

the clips slide over protrusions on the headlight I travelled some 15K KLM with it like this with no issues as the front is still held together from below

The second time (2018) I broke the orange clip. this holds an upper panel in place and should be intact. I glued it with crazy glue, seems to be fine so far.

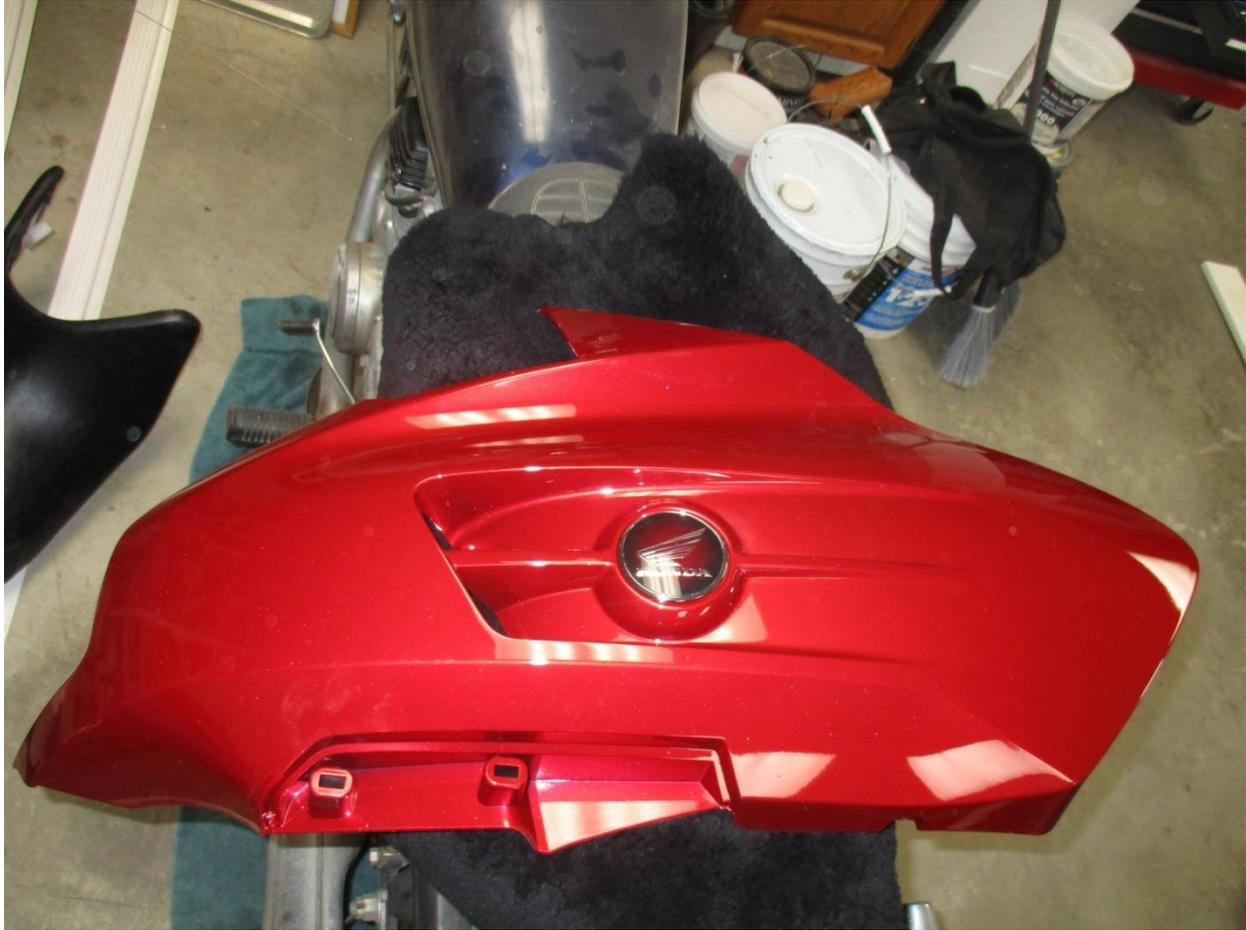
outer view of the new panel

This was \$138 CDN in 2015

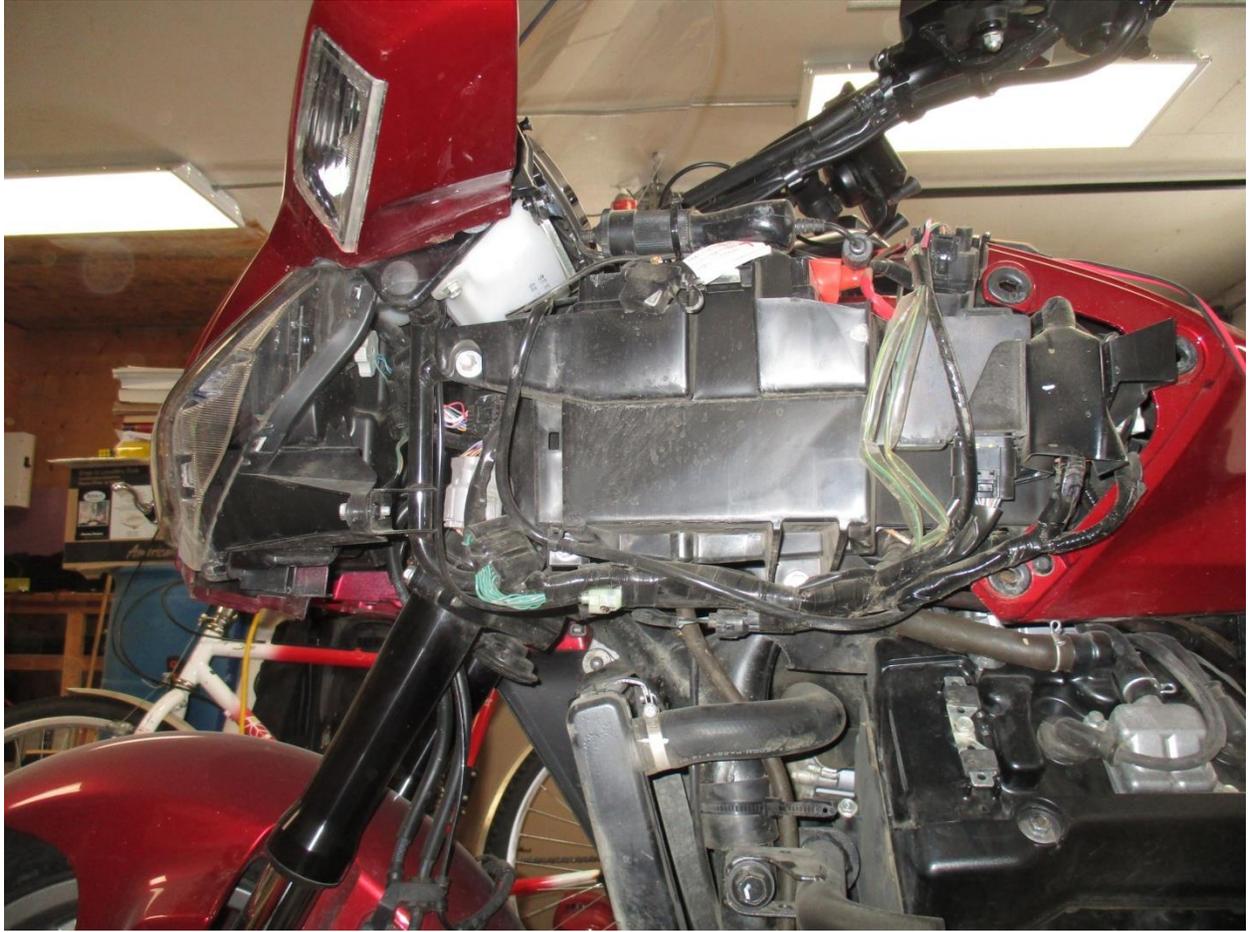
Left side removed

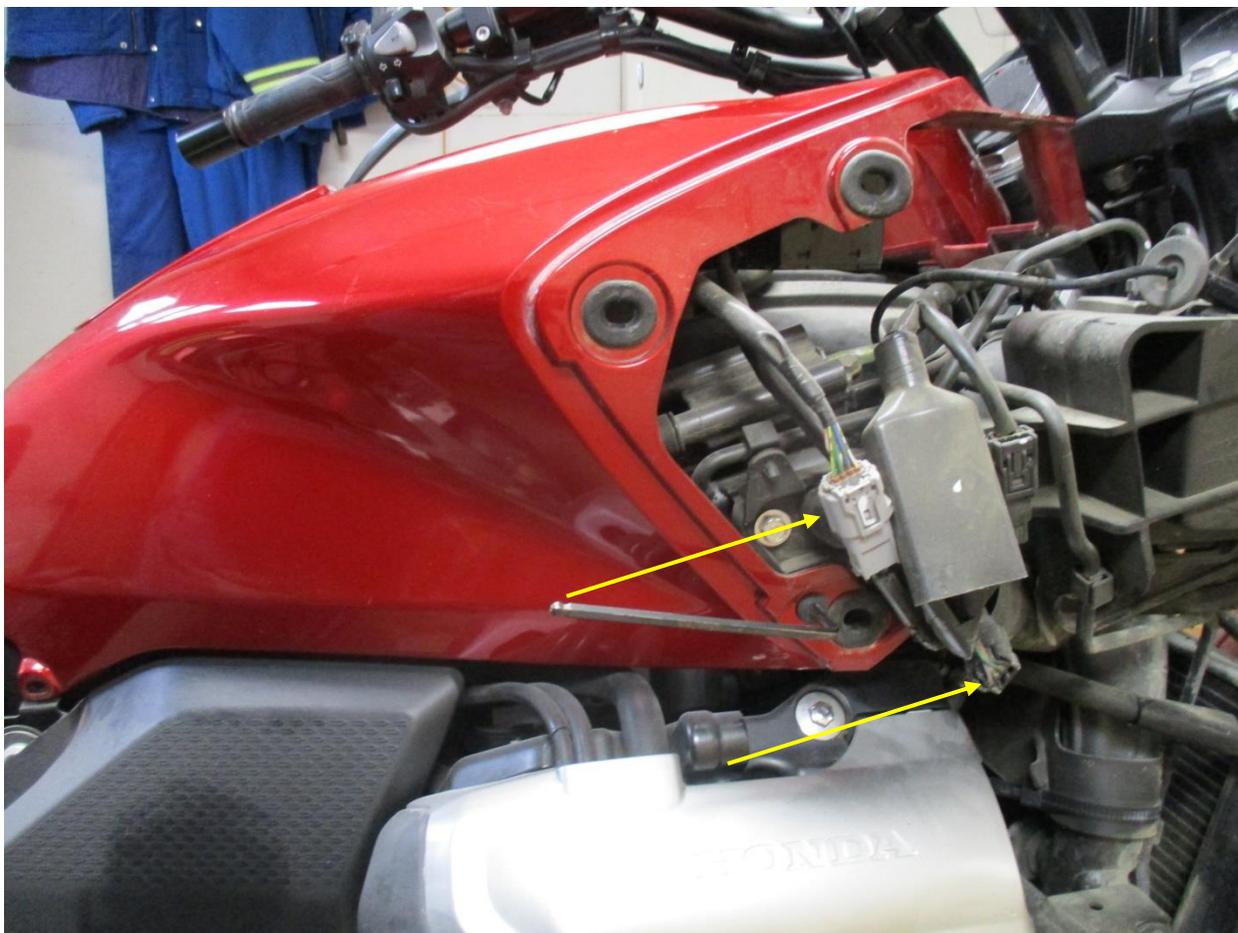
There is wiring to disconnect on each side before removing the center cowl

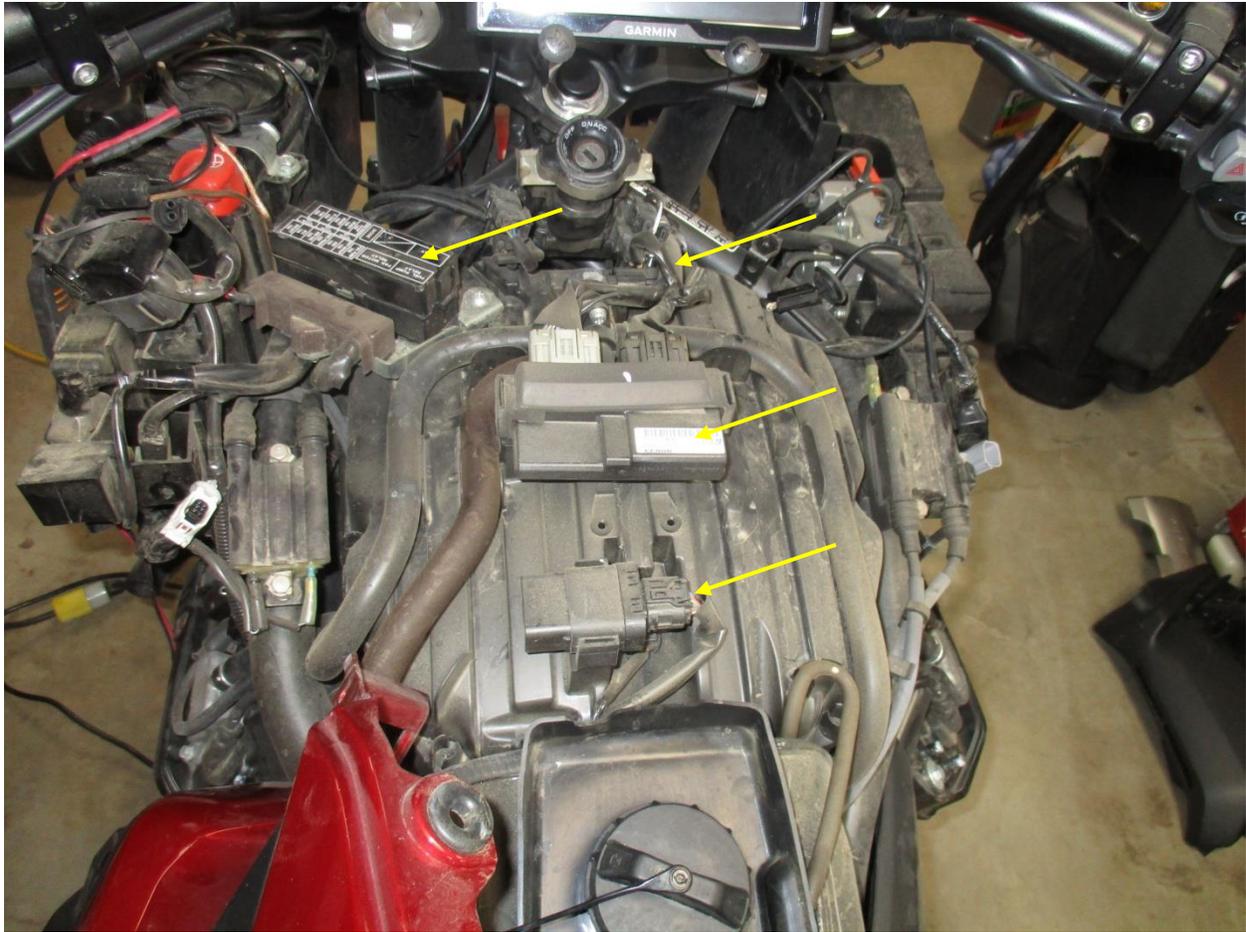
Top view with all plastic off

I moved the main center cowling back toward the seat, this way I did not need to remove the gas filler lid mechanism

Arrows identify electrical items to be removed/replaced

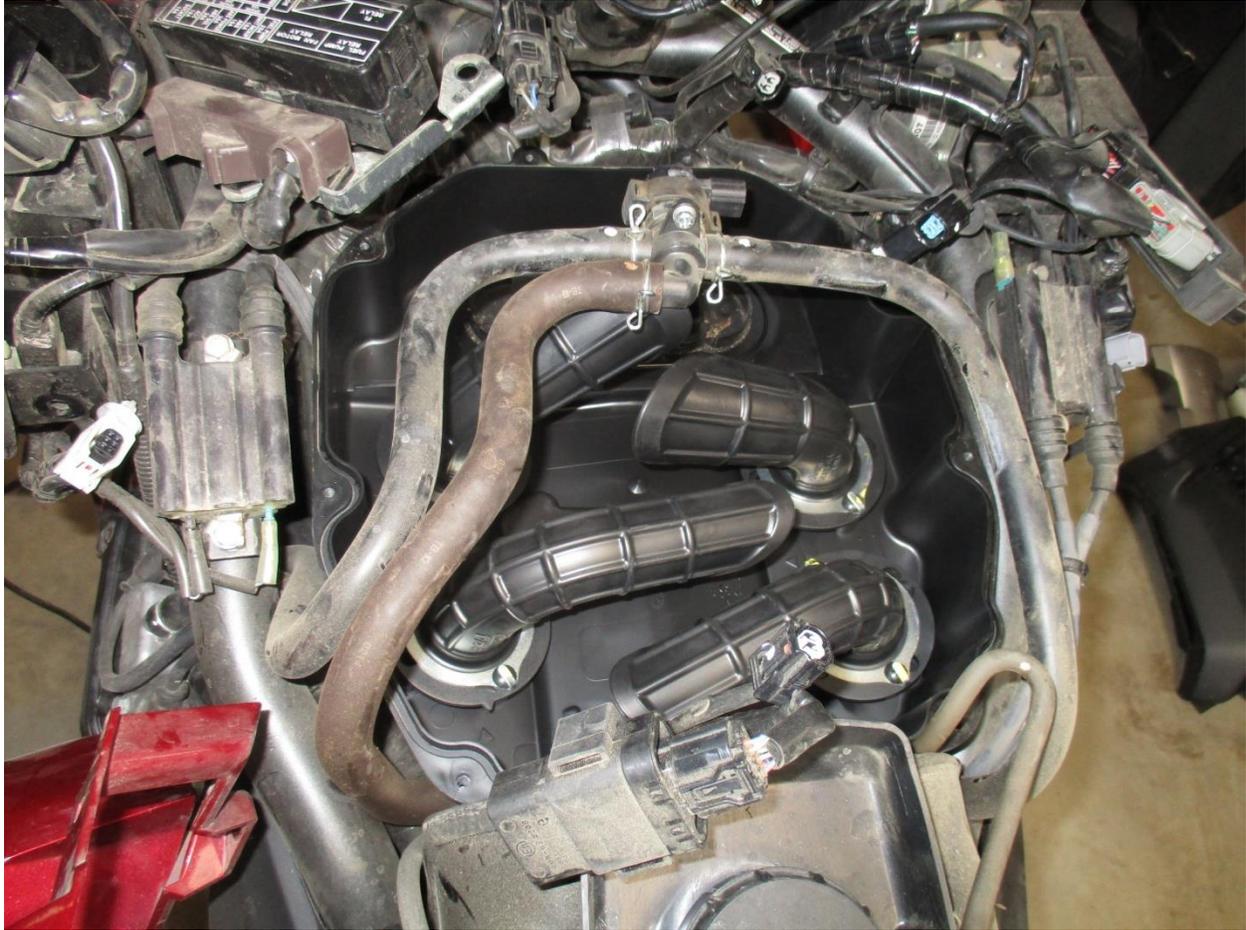
Air box with the cover and filter removed

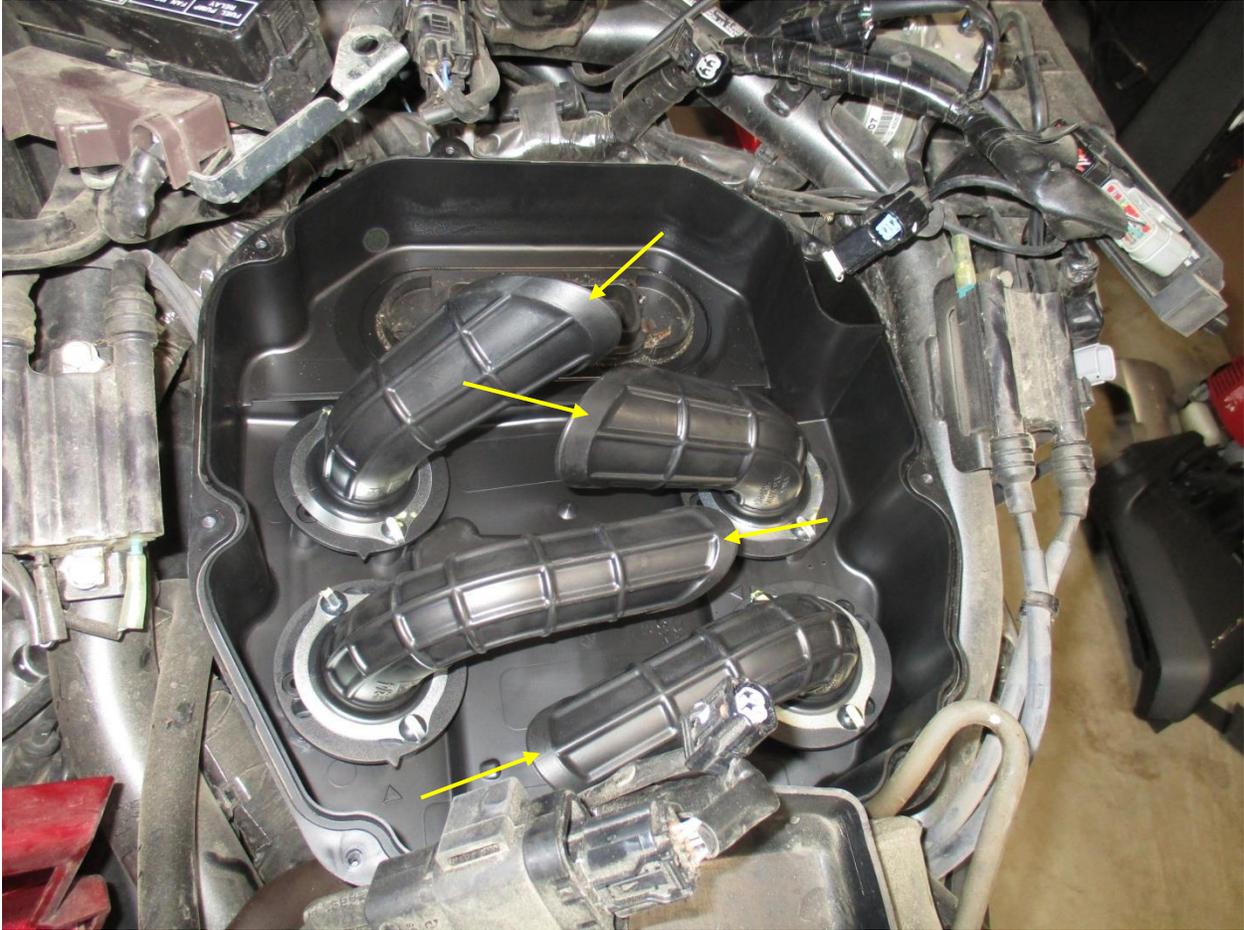
The air box with hoses moved out of the way  
Inserting a finger inside each venturi, there was no oil or dirt.

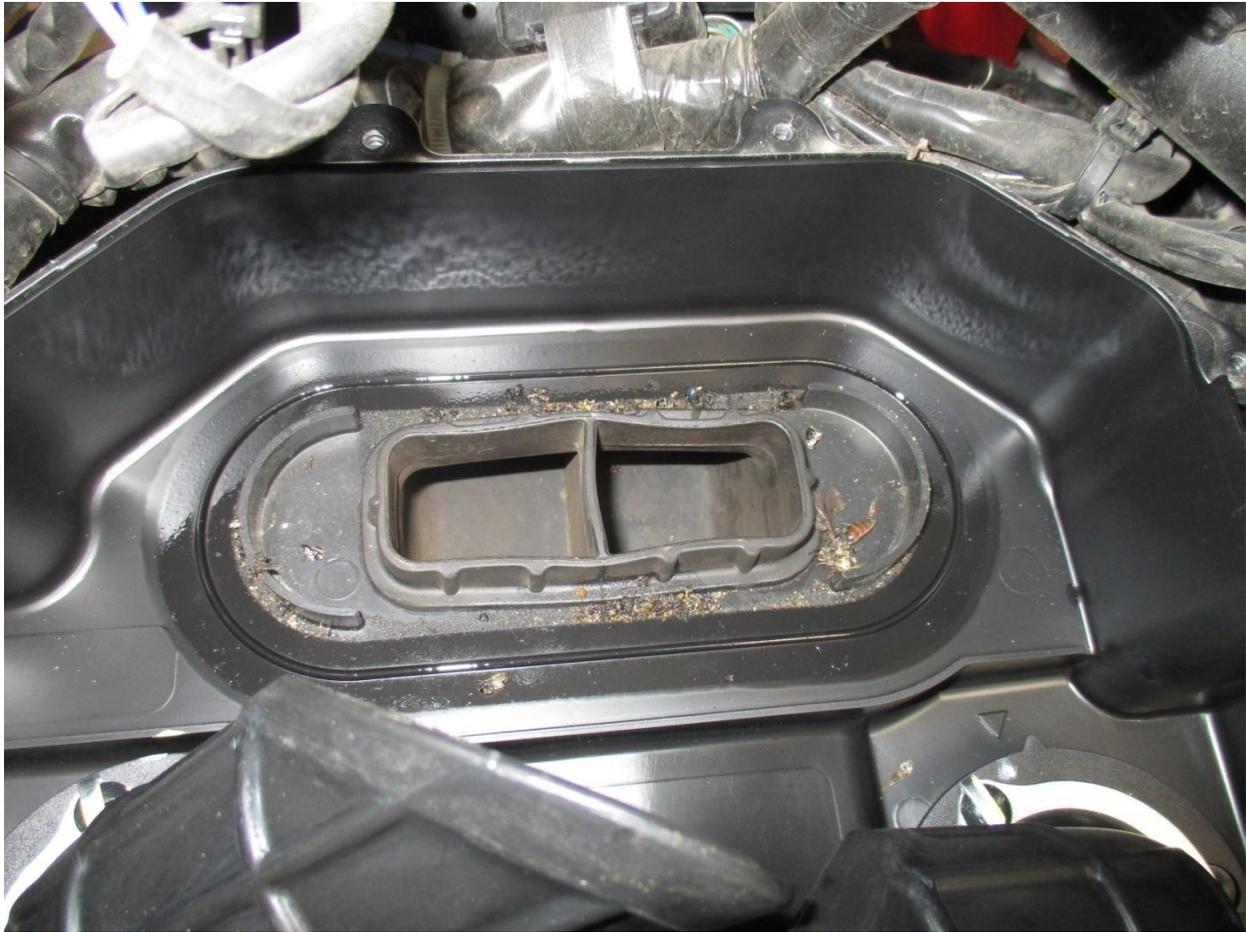
There was some dirt from the air intakes but nothing serious.

This residue was vacuumed up (2018)

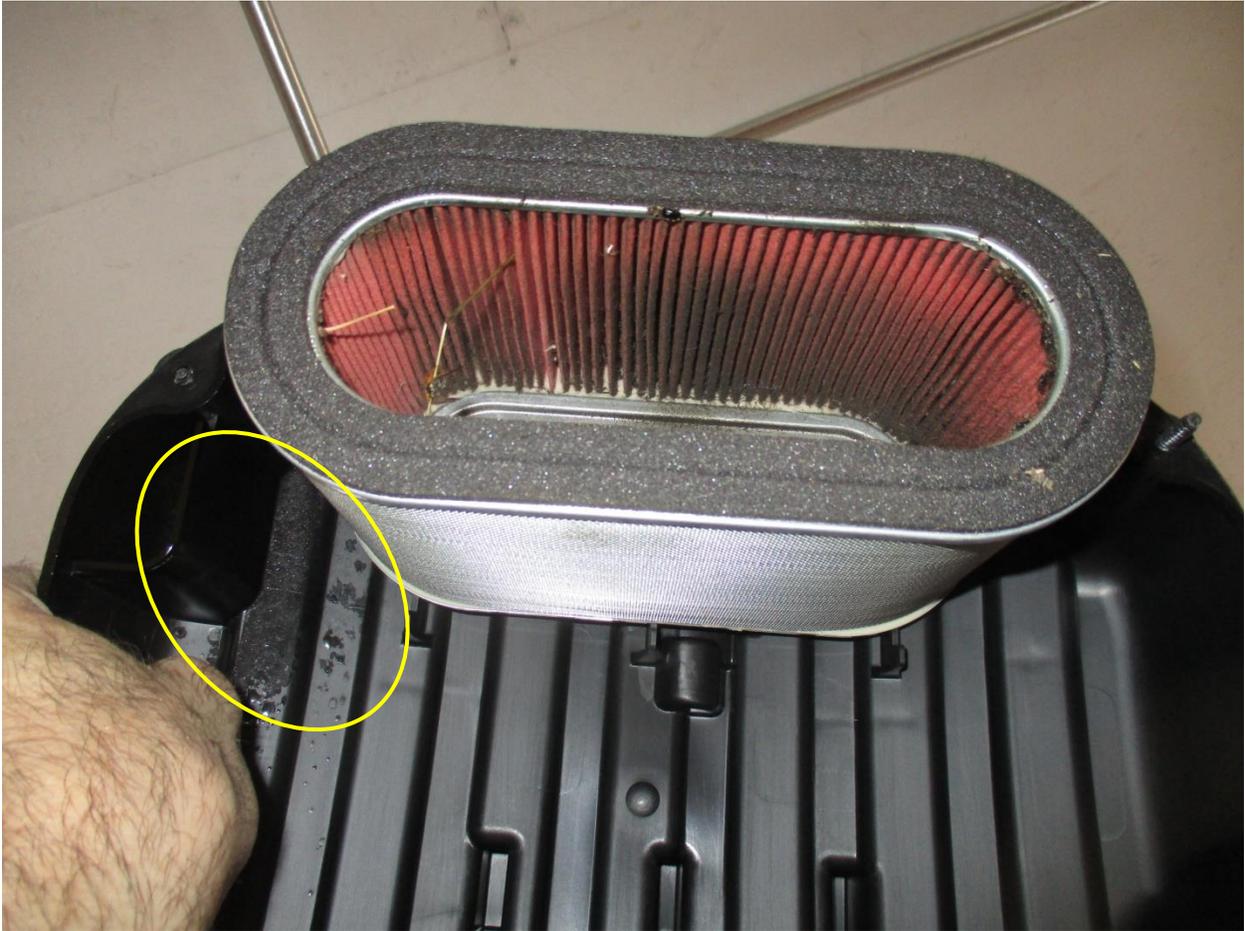
The old air filter with 29,632 KLM (3 years)

I ride in the country but on interstates and main hi-ways, no gravel

The oil droplets were the same in 2018 & 2021

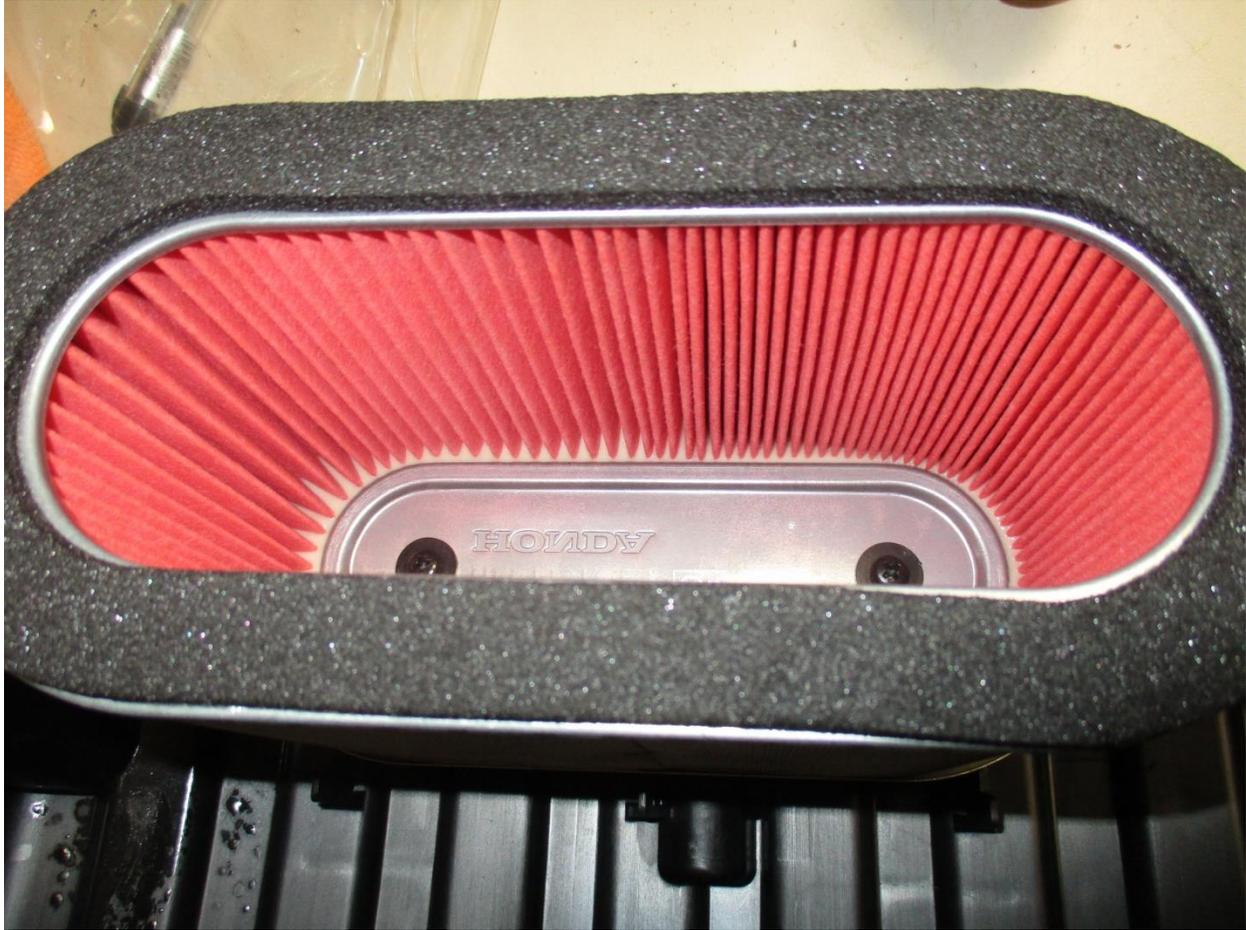
The outer foam (bottom seal) was oily from the factory.

New air filter installed with 2 screws

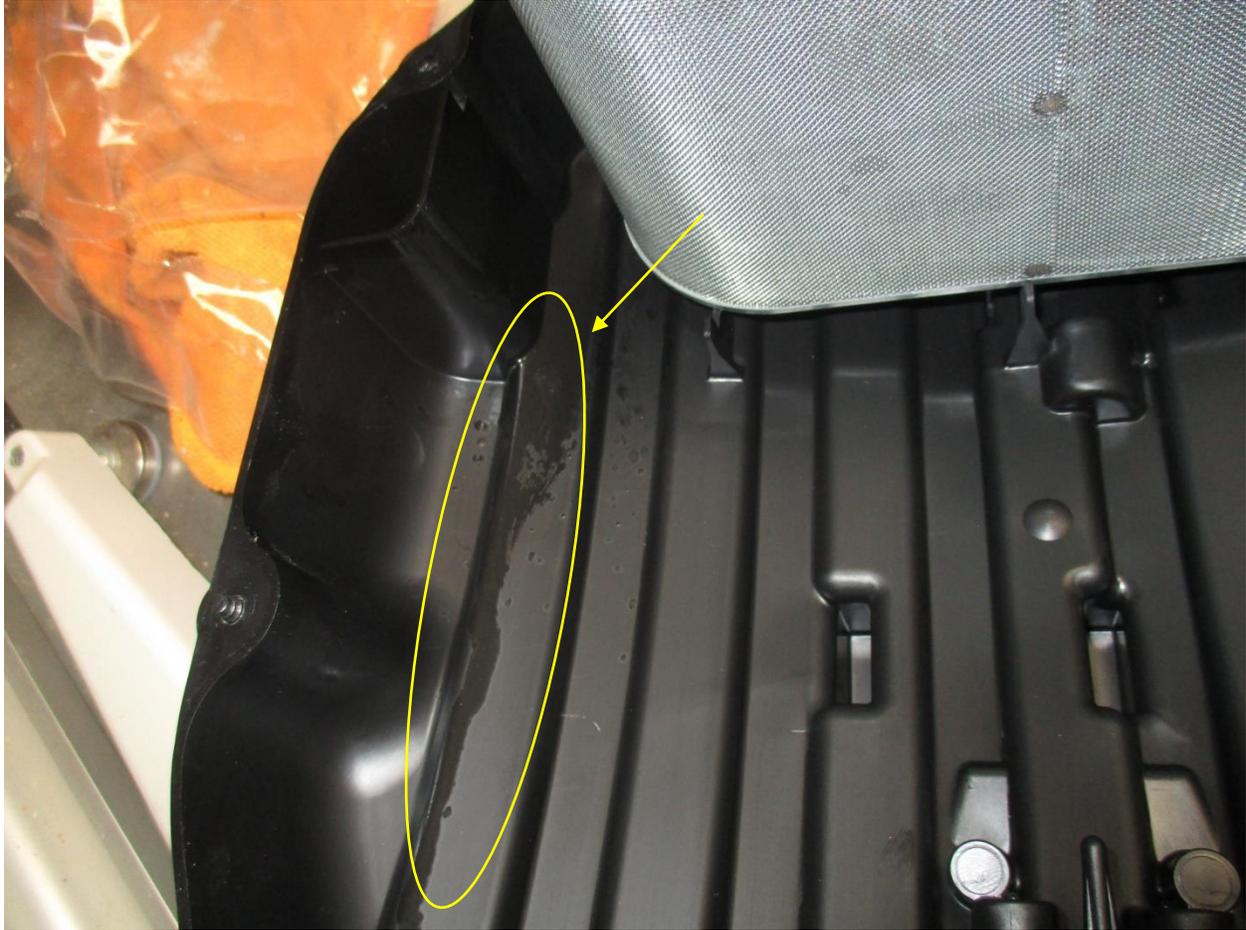
There was a very small stain of oil in the air box, this was wiped clean before re-assembly. (2018)

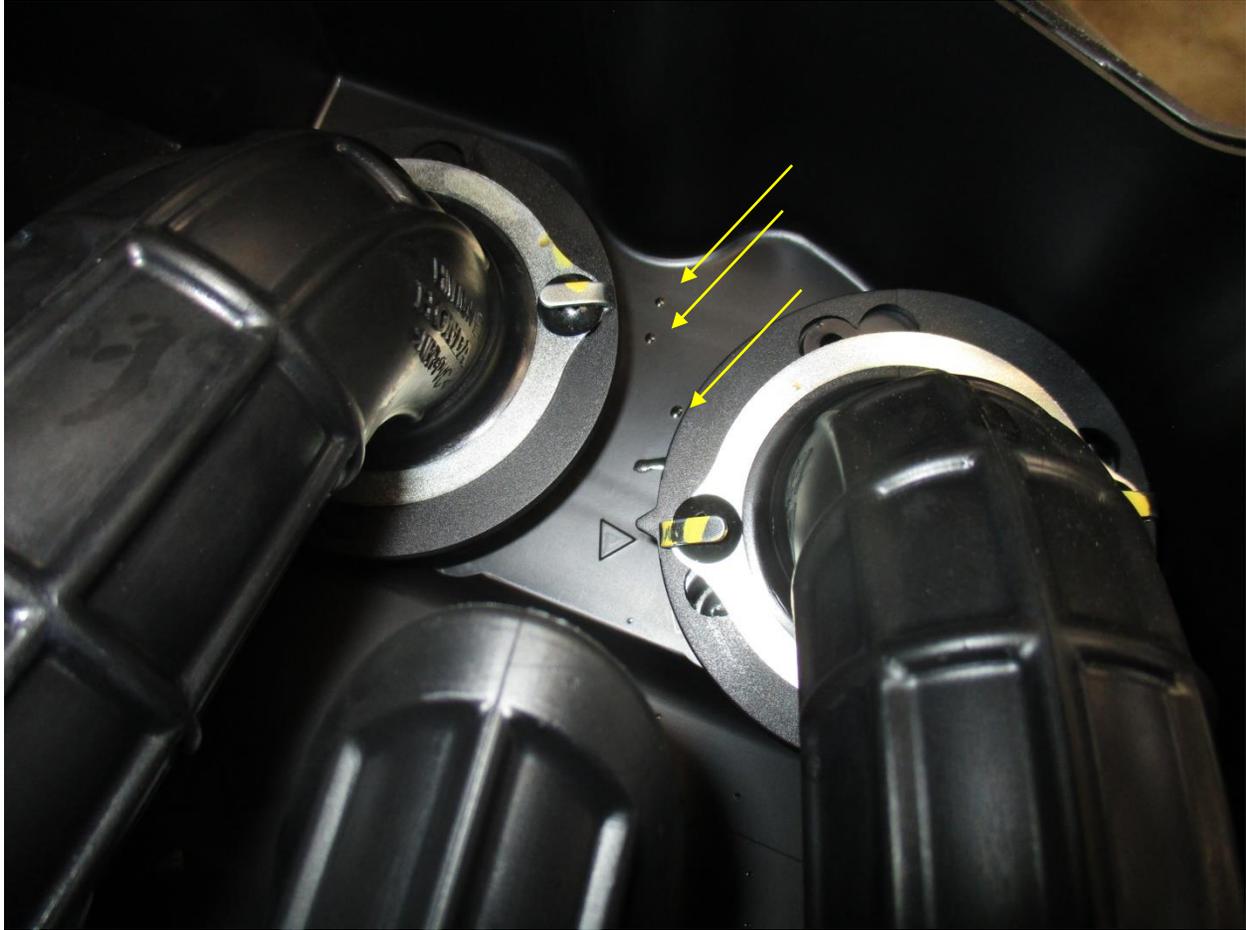
small droplets of oil (both 2018 & 2021)

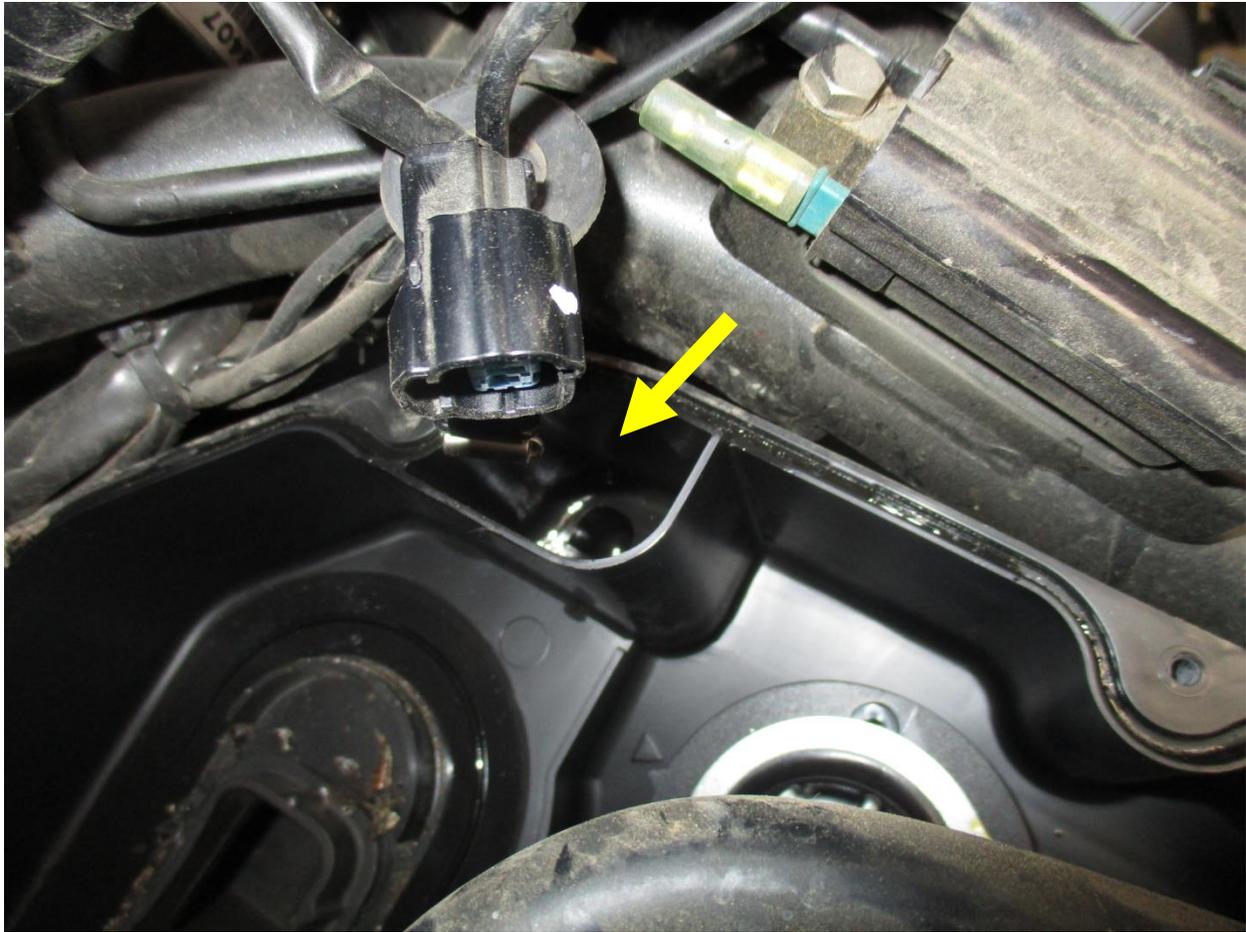
This is some sort of oil cavity, possibly for engine blowback (PCV valve)

If so, the valve will be changed

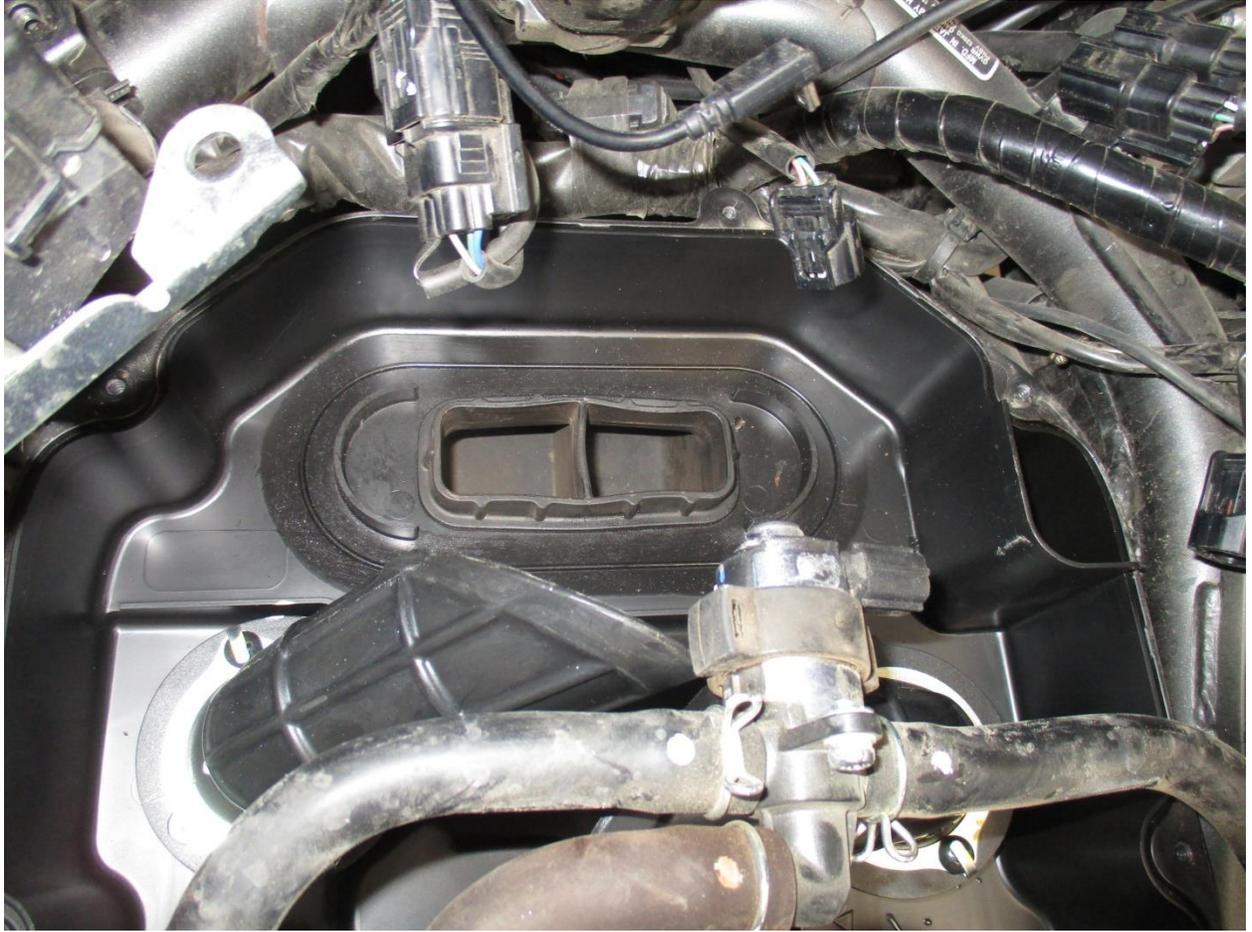
Clean & ready for reassembly (2018)

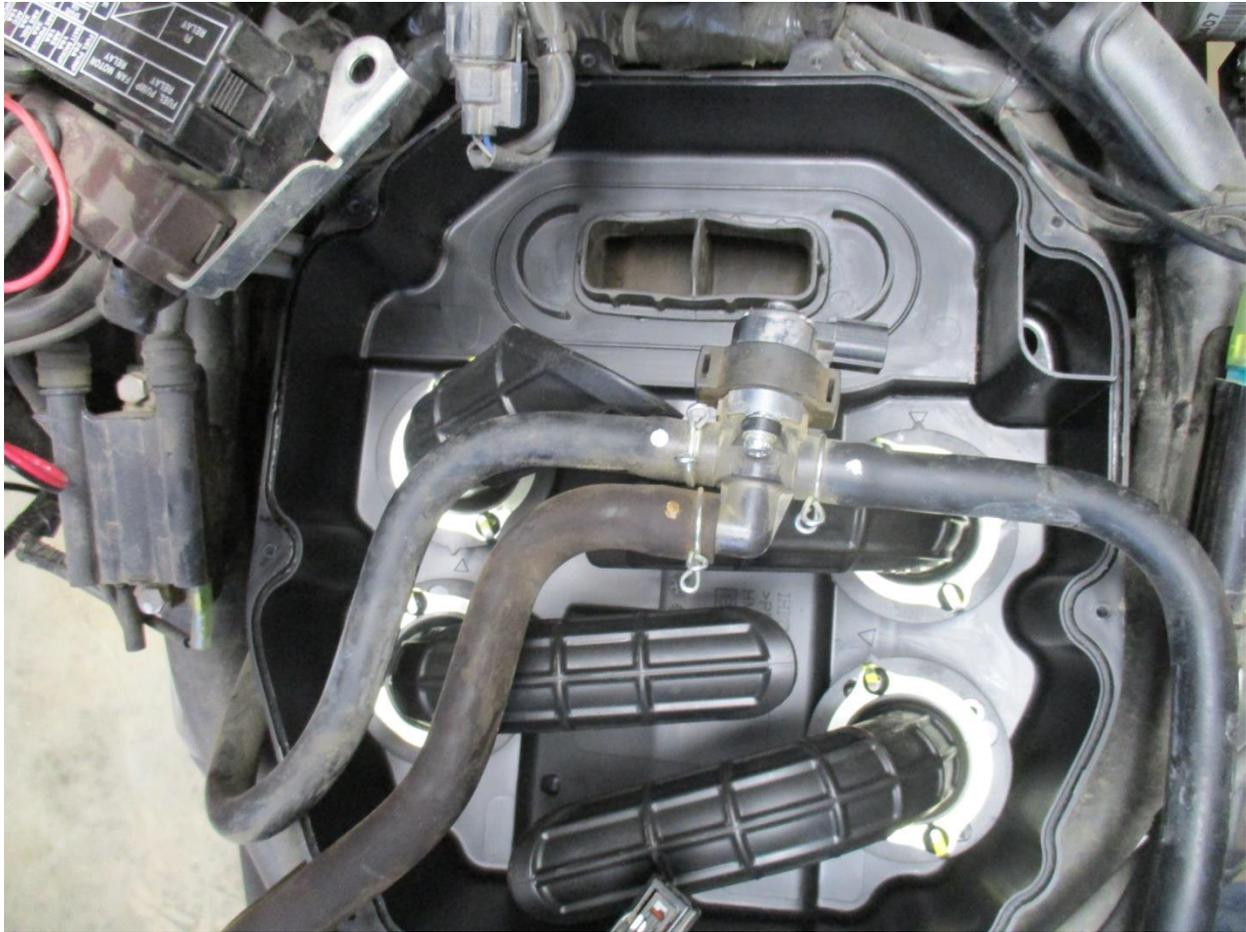
Clean & ready for reassembly (2021)
