Replacing the air filter on a CTX1300 (Mar 2018)

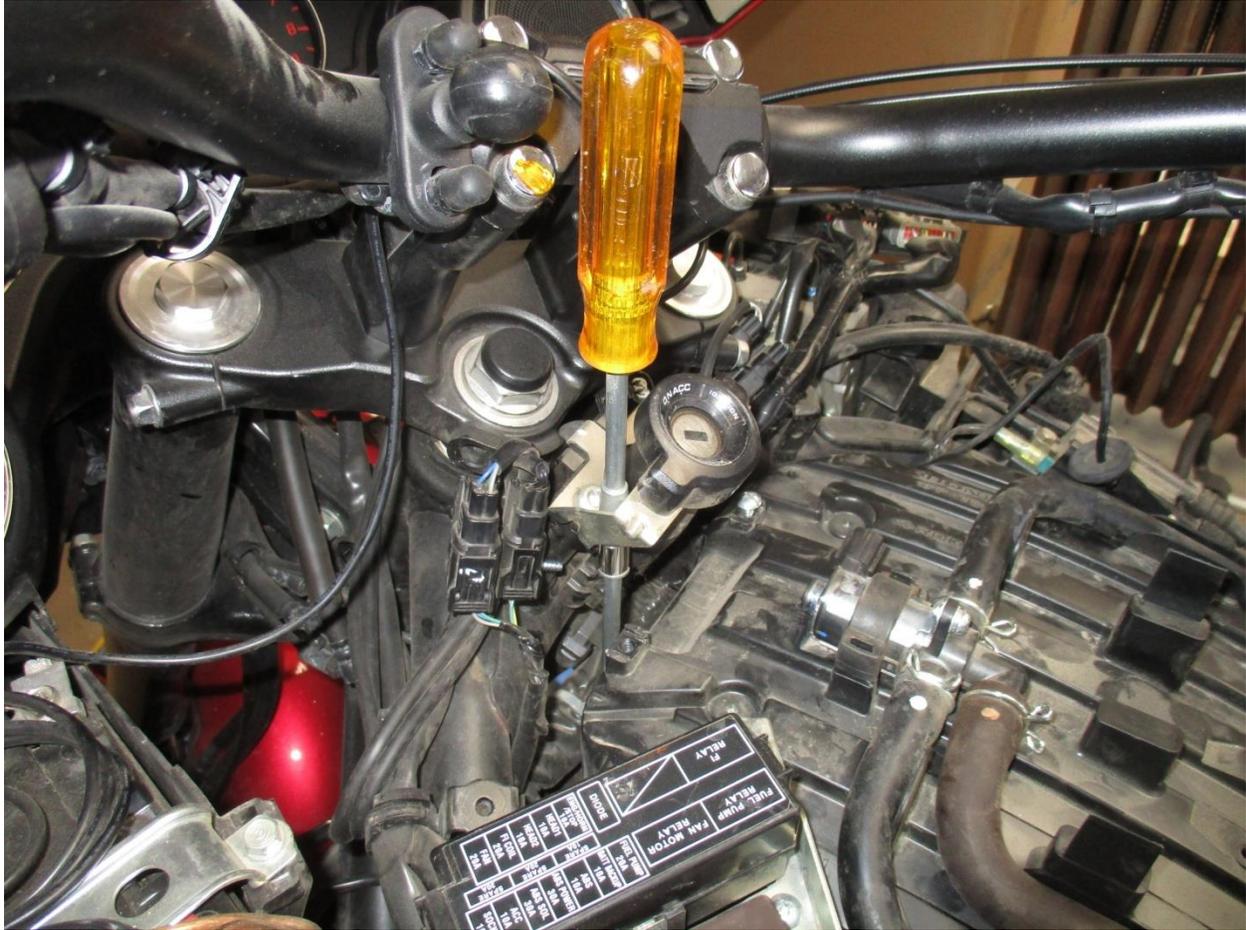
Getting at on air-box screw required a long shaft #2 Phillips screwdriver

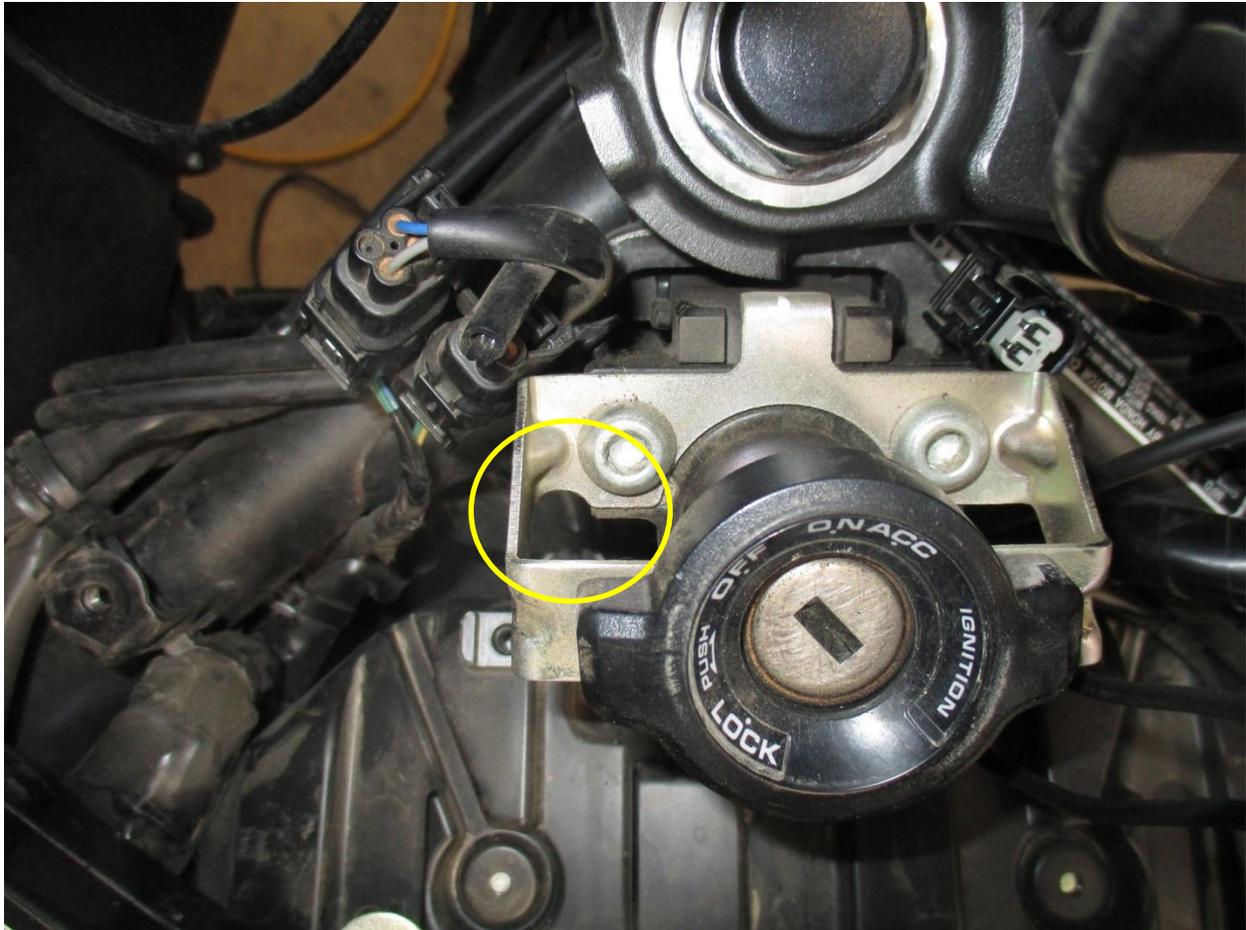
Yep, there is even a bracket mod done to accommodate this requirement
